**Flood Control Project Maintenance  
Levee Inspections**

**Maintenance Issue Types Only, Levee Inspection Report By Mile - Fall 2018**

**Reclamation District No. 0150 Merrit Island**

Waterway	Bank	Unit Miles	Inspection Start/End	Inspector
Unit No. 01 Sutter Slough	Left	0.52	11/09/2018 11/09/2018	Luz Dial

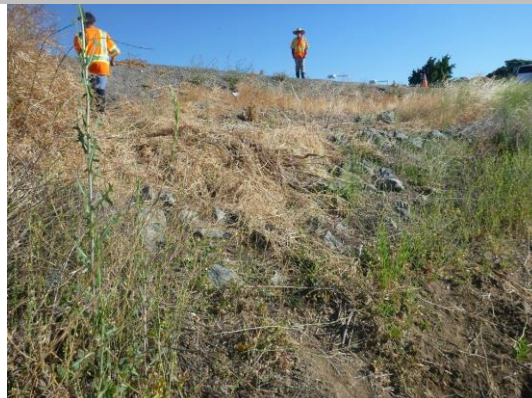
Photo 3 of 3 : LEVAL\_FA\_2018\_286\_2140.jpg

LM Start	0.11	Rating **	A/W	Issue No.	46 (cont)	
LM End	0.14	Issue Type +	Ma	Location *	WS	
Category	Supplemental			GPS Latitude/Longitude		
				Start	End	
Item	2017 Storm Damage			38.329369 °	38.329767 °	
				-121.574936 °	-121.574589 °	
DWR ID	DWR_RD0150_02_f_2017_46					
Comment Code						
Inspector Comment						
Levee Evaluation Comments						
Description: The flood damage consists of a waterside erosion approximately 185 feet long on the west (right) bank of the Sacramento River. See attached pages for photos.						
Site ID No: 286						
Site Designation: LMA-112						
Repair Type: Erosion						
Rating: Area of Concern						
Field Date: 7/17/2017						
Notes: Crown is a paved road. Scarps upto 3 ft deep, not fully vertical though. Area of concern because erosion is not very deep into prism.

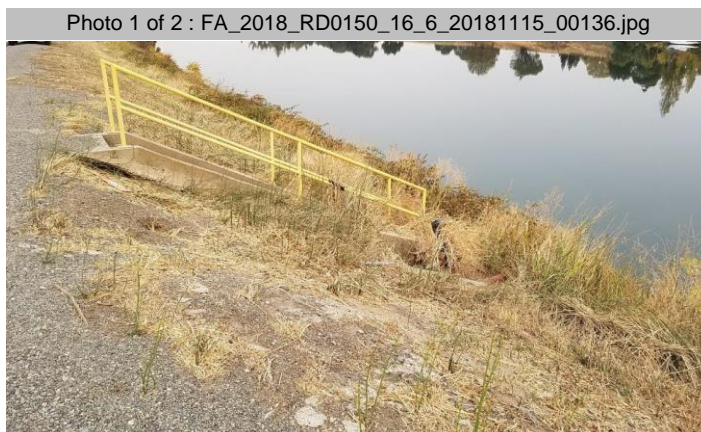
LM Start	0.38	Rating **	M	Issue No.	6
LM End	0.38	Issue Type +	Ma	Location *	WS
Category	Earthen Levee			GPS Latitude/Longitude	
				Start	End
Item	Slope Stability			38.332598°	38.332598°
				-121.572179°	-121.572179°
DWR ID	DWR_RD0150_02_s_2012_6				
Comment Code					
S2 : Repair the levee slope damaged by foot traffic and prevent access where possible.					
Inspector Comment

View of slope instability around stairway. Fall 2018

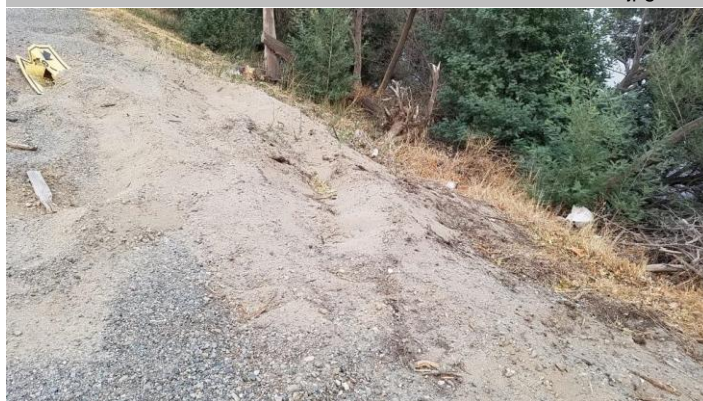
Photo 1 of 1 : FA\_2018\_RD0150\_16\_45\_20181115\_00138.jpg

LM Start	<b>0.59</b>	Rating **	M	Issue No.	<b>45</b>							
LM End	<b>0.59</b>	Issue Type +	Ma	Location *	WS							
Category	Earthen Levee		GPS Latitude/Longitude									
			Start	End								
Item	Slope Stability		38.334898°	38.334898°								
			-121.569632°	-121.569632°								
DWR ID	DWR_RD0150_02_f_2018_45											
Comment Code												
S3 : Repair the levee slope damaged by vehicle traffic and prevent access where possible.												
Inspector Comment

View of slope damage likely from vehicle traffic. Fall 2018

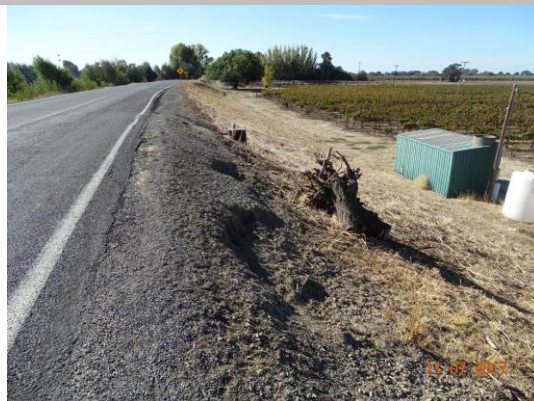
Photo 1 of 2 : FA\_2018\_RD0150\_16\_59\_20180910\_00040.jpg

LM Start	<b>0.71</b>	Rating **	M	Issue No.	<b>59</b>							
LM End	<b>0.71</b>	Issue Type +	Ma	Location *	LS							
Category	Earthen Levee		GPS Latitude/Longitude									
			Start	End								
Item	Encroachments		38.336291°	38.336291°								
			-121.568260°	-121.568260°								
DWR ID	DWR_RD0150_02_s_2016_59											
Comment Code												
TR : Tree or limb												
Inspector Comment												
Damaged tree roots and trunks appear to damage landside slope of the levee and need to be removed.

View of the tree trunk on the landside of the levee. Fall 2017

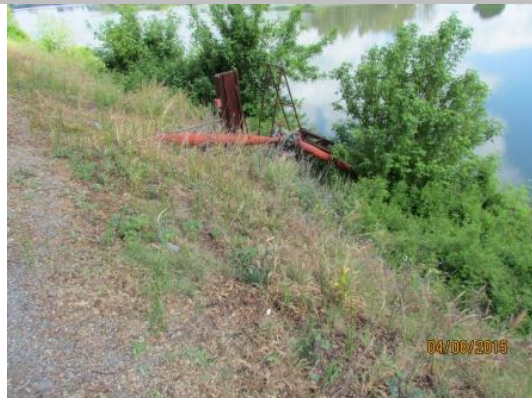
Photo 1 of 5 : FA\_2018\_RD0150\_16\_961\_20180910\_00065.jpg

LM Start	3.24	Rating **	M	Issue No.	961
LM End	3.24	Issue Type +	Ma	Location *	WS
Category	Earthen Levee			GPS Latitude/Longitude	
				Start	End
Item	Erosion / Bank Caving			38.355321 °	38.355321 °
				-121.530902 °	-121.530902 °
DWR ID	DWR_RD0150_02_s_2012_961				
Comment Code					
E2 : Schedule repair of erosion site prior to the next inspection.					
Inspector Comment					
Depressions into the waterward slope can be seen along the waterward slope at this site. Also note the damaged pump support, pump, and pipe just upstream of the site; they may contribute to the erosion in a high water event and should be removed.

View of the erosion on the waterside of the levee during spring 2015 inspection.

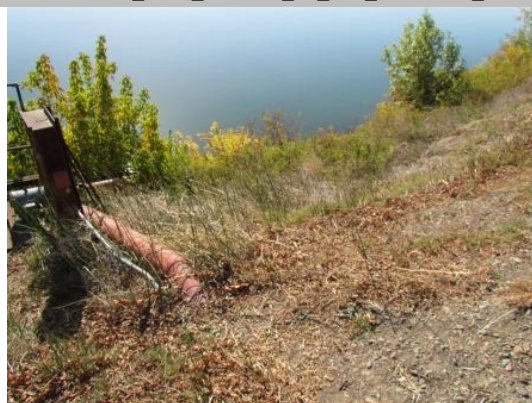
Photo 2 of 5 : FA\_2018\_RD0150\_16\_961\_20180910\_00066.jpg

View of the erosion on the waterside slope of the levee near the pipe looking downstream. This picture was taken during the fall 2013 inspection.

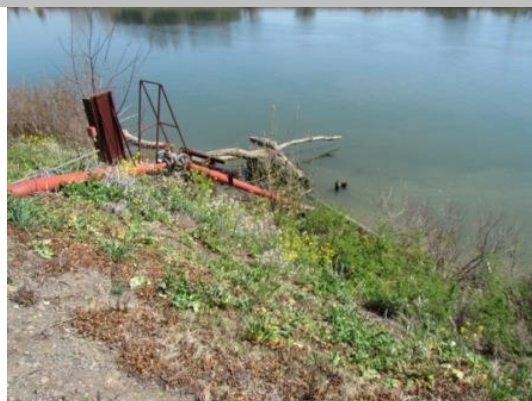
Photo 3 of 5 : FA\_2018\_RD0150\_16\_961\_20180910\_00067.jpg

View of the erosion on the waterside slope of the levee looking upstream during spring 2013 inspection.

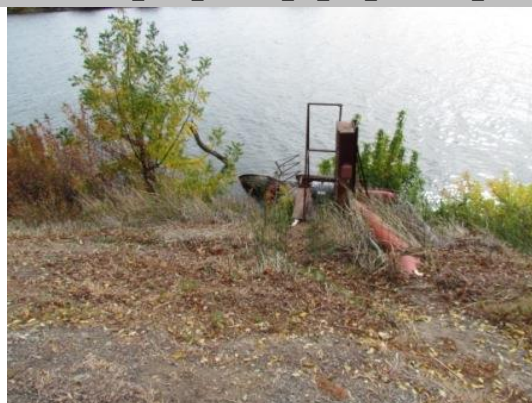
Photo 4 of 5 : FA\_2018\_RD0150\_16\_961\_20180910\_00068.jpg

View of erosion and damaged pipe and abandoned boat on the waterside of the levee looking upstream. This picture was taken during fall 2012 inspection.

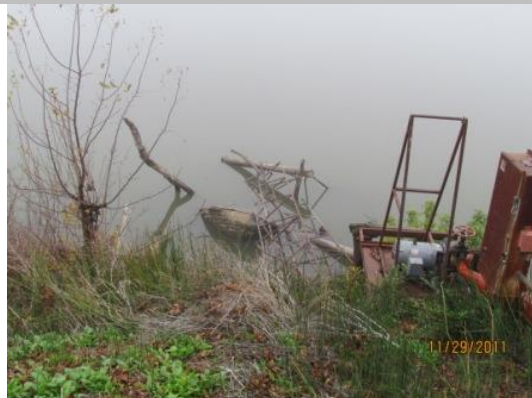
Photo 5 of 5 : FA\_2018\_RD0150\_16\_961\_20180910\_00069.jpg

View of the erosion site, and broken pump support along with a boat on the waterside of the levee. The picture was taken from the crown looking towards the toe of the levee during fall 2011 inspection.

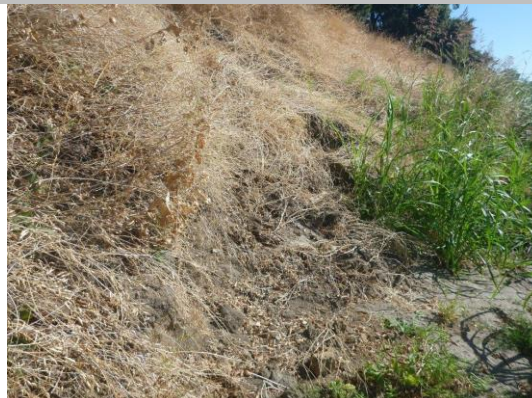
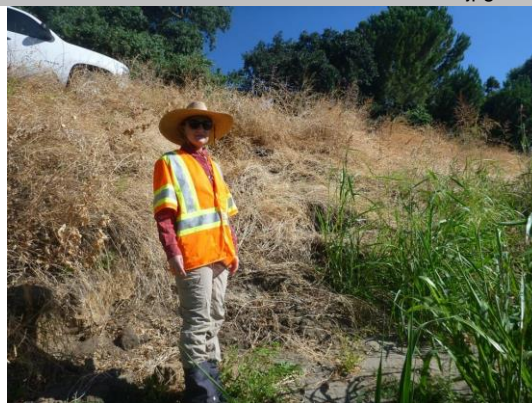
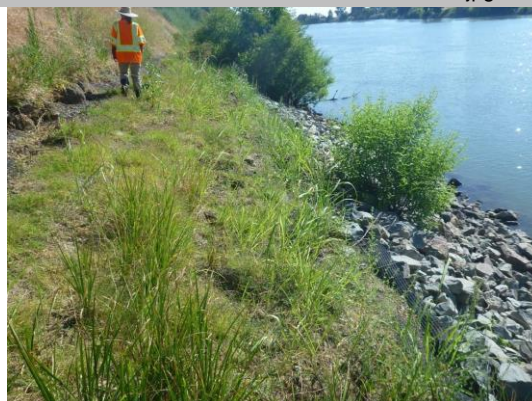
LM Start	3.42	Rating **	A/W	Issue No.	47
LM End	3.46	Issue Type +	Ma	Location *	WS
Category	Supplemental			GPS Latitude/Longitude	
				Start	End
Item	2017 Storm Damage			38.357183 °	38.357631 °
				-121.528547 °	-121.527981 °
DWR ID	DWR_RD0150_02_f_2017_47				
Comment Code					
Inspector Comment					
Levee Evaluation Comments					
Description:The flood damage consists of a waterside erosion approximately 229 feet long on the west (right) bank of the Sacramento River. See attached pages for photos.					
Site ID No:287					
Site Designation:LMA-113					
Repair Type: Erosion					
Rating:Serious					
Field Date:7/17/2017					
Notes: Crown is a paved road. Erosion scarps upto 10 ft deep and within 5 ft of crown. Worse conditions on the DS end. Exposed filter fabric. Serious because of depth of erosion into levee, weak soil, and proximity to crown which is a high traffic public road.

Comment Code					
Inspector Comment					
Levee Evaluation Comments					
Description:The flood damage consists of a waterside erosion approximately 229 feet long on the west (right) bank of the Sacramento River. See attached pages for photos.					
Site ID No:287					
Site Designation:LMA-113					
Repair Type: Erosion					
Rating:Serious					
Field Date:7/17/2017					
Notes: Crown is a paved road. Erosion scarps upto 10 ft deep and within 5 ft of crown. Worse conditions on the DS end. Exposed filter fabric. Serious because of depth of erosion into levee, weak soil, and proximity to crown which is a high traffic public road.

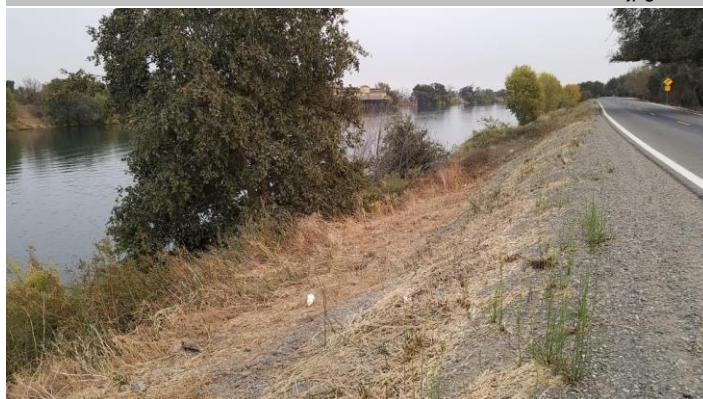
Photo 1 of 2 : FA\_2018\_RD0150\_16\_44\_20181115\_00139.jpg

LM Start	4.50	Rating **	U	Issue No.	44
LM End	4.57	Issue Type +	Ma	Location *	WS
Category	Supplemental			GPS Latitude/Longitude	
				Start	End
Item	2017 USACE Erosion Survey, DRAFT			38.370928 °	38.371909 °
				-121.523069 °	-121.523316 °
DWR ID	DWR_RD0150_02_f_2018_44				
Comment Code					
Inspector Comment					
2017 Site ID: SAC 38.5 R Status: Critical 2017 Field Notes: New erosion pocket. Vertical section along lower bank, and cracking. Upgraded to critical. Site History: 1999 - Downstream end (300 ft) repaired with rock. 2010 - Toe erosion, some vertical slopes lower down. 2011 - Failing rock repair. Slumping of the lower bank. Minor new erosion. 2013 - Tree at upstream end has exposed roots. Some new erosion.  Fall 2018 DWR Inspection: Erosion along lower bank and cracking not visible from levee crown due to vegetation.

View of waterside slope. Fall 2018

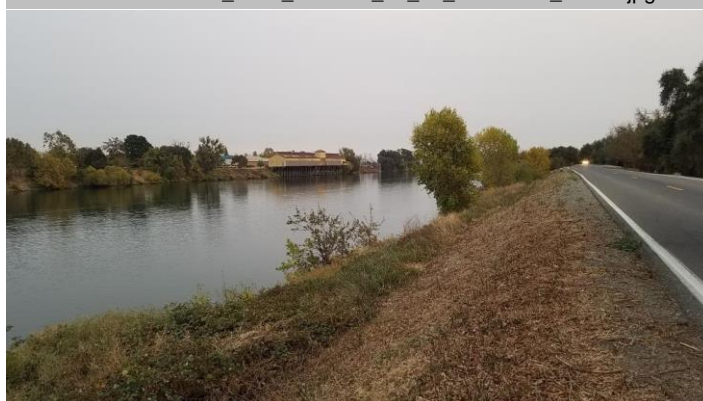
Photo 2 of 2 : FA\_2018\_RD0150\_16\_44\_20181115\_00140.jpg

LM Start	4.50	Rating **	U	Issue No.	44 (cont)	
LM End	4.57	Issue Type +	Ma	Location *	WS	
Category	Supplemental			GPS Latitude/Longitude		
				Start	End	
Item	2017 USACE Erosion Survey, DRAFT			38.370928 °	38.371909 °	
				-121.523069 °	-121.523316 °	
DWR ID	DWR_RD0150_02_f_2018_44					
Comment Code						
Inspector Comment						
2017 Site ID: SAC 38.5 R						
Status: Critical						
2017 Field Notes: New erosion pocket. Vertical section along lower bank, and cracking. Upgraded to critical.						
Site History: 1999 - Downstream end (300 ft) repaired with rock. 2010 - Toe erosion, some vertical slopes lower down. 2011 - Failing rock repair. Slumping of the lower bank. Minor new erosion. 2013 - Tree at upstream end has exposed roots. Some new erosion.						
Fall 2018 DWR Inspection: Erosion along lower bank and cracking not visible from levee crown due to vegetation.

View of waterside slope. Fall 2018

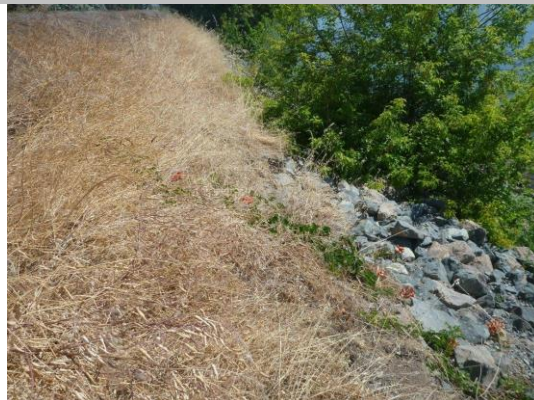
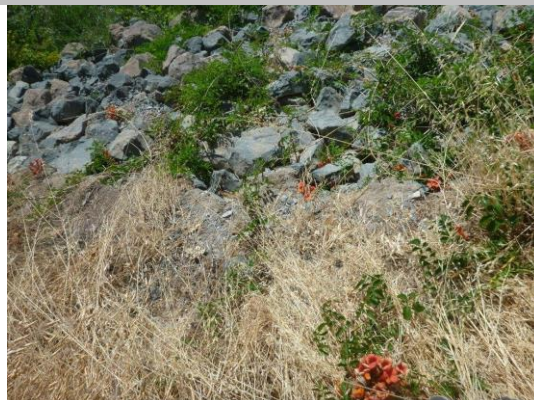
Comment Code					
Inspector Comment					
Levee Evaluation Comments					
Description:The flood damage consists of a waterside erosion approximately 447 feet long on the west (right) bank of the Sacramento River. See attached pages for photos.					
Site ID No:288					
Site Designation:LMA-114					
Repair Type: Erosion					
Rating:Area of Concern					
Field Date:7/17/2017					
Notes: Crown is a paved road. Much of site was not accessible because of thorny veg. Scarps were only about 1 ft deep where it was accessible so rated it a lower priority. Irrigation pipe within the site. A boat view would be helpful here. Fall 2018 DWR Inspector: Erosion along bank not visible from levee crown.

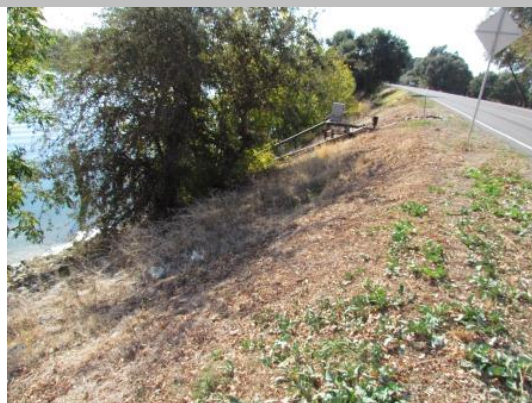
Photo 1 of 2 : FA\_2018\_RD0150\_16\_975\_20180910\_00070.jpg

LM Start	5.24	Rating **	M	Issue No.	975
LM End	5.24	Issue Type +	Ma	Location *	WS
Category	Earthen Levee			GPS Latitude/Longitude	
				Start	End
Item	Slope Stability			38.381126 °	38.381126 °
				-121.524207 °	-121.524207 °
DWR ID	DWR_RD0150_02_s _ 2013_975				
Comment Code					
S1 : Repair slope instability.					
Inspector Comment					
Depression on the waterward slope at the shoulder over an irrigation pipe.

View of minor slope instability on the waterside slope of the levee looking downstream during fall 2013 inspection.

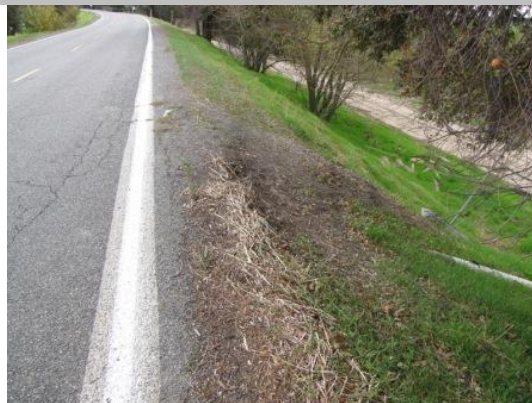
Photo 2 of 2 : FA\_2018\_RD0150\_16\_975\_20180910\_00071.jpg

View of a minor depression along the landward slope of the levee over a pipe penetration looking downstream.

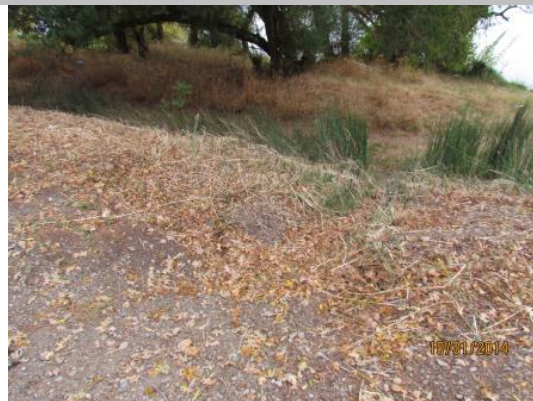
LM Start	<b>5.33</b>	Rating **	M	Issue No.	<b>54</b>
LM End	<b>5.33</b>	Issue Type +	Ma	Location *	WS
Category	Earthen Levee		GPS Latitude/Longitude		
			Start	End	
Item	Slope Stability		38.382072 °	38.382072 °	
			-121.523220 °	-121.523220 °	
DWR ID	DWR_RD0150_02_f_2014_54				
Comment Code					
S2 : Repair the levee slope damaged by foot traffic and prevent access where possible.					
Inspector Comment

View of slope instability on the waterside of the levee looking towards the toe. Fall 2014

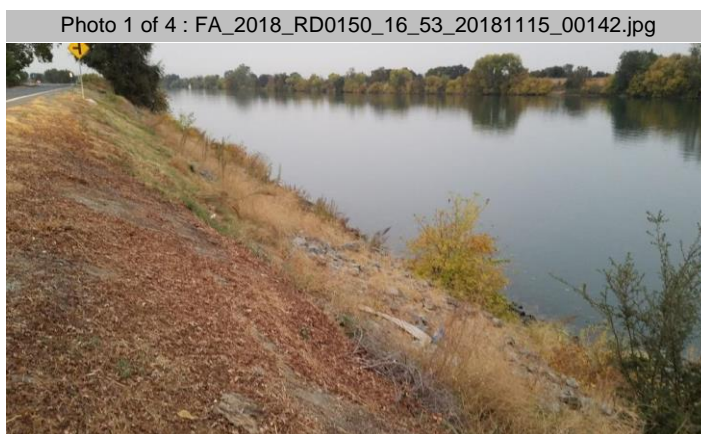
View of waterside slope with some revetment. Fall 2018

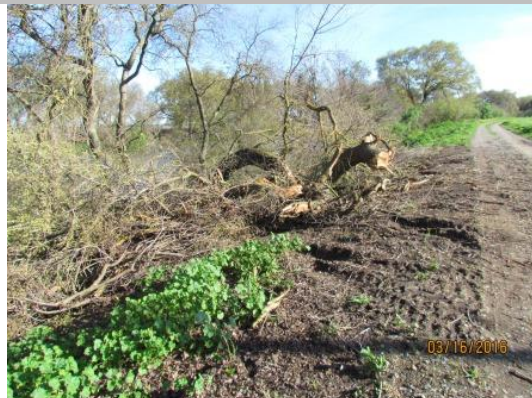
View of broken tree trunk on the waterside slope of the levee.

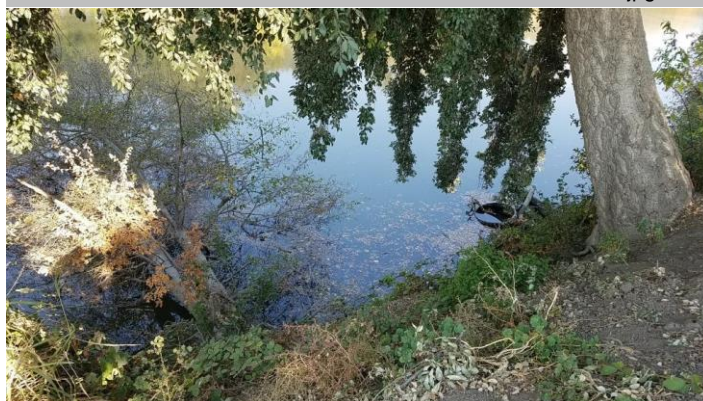
View of slope damage near fallen tree. Fall 2018

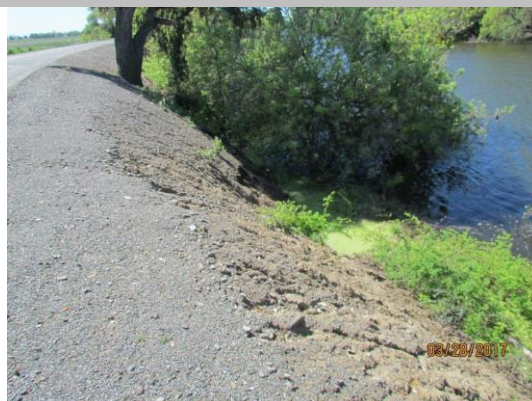
View of slope instability on the waterside slope of the levee looking downstream. Spring 2017

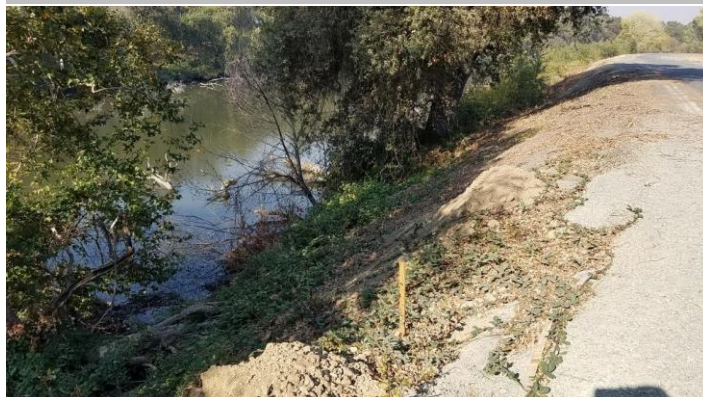
View of erosion at top of slope. Fall 2018

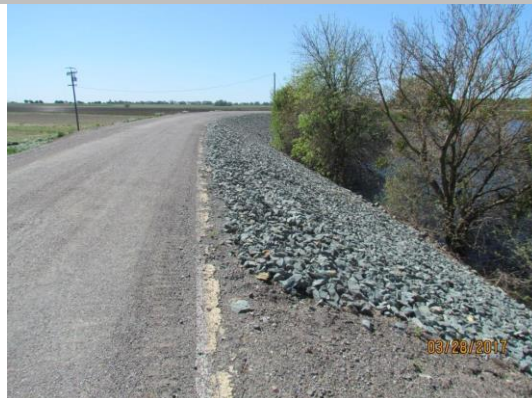
View of the new riprap on the waterside slope of the levee looking downstream. Spring 2017

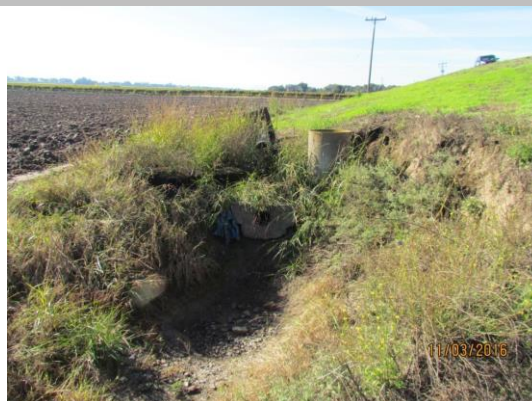
View of the ditch on the landside toe of the levee. Fall 2016

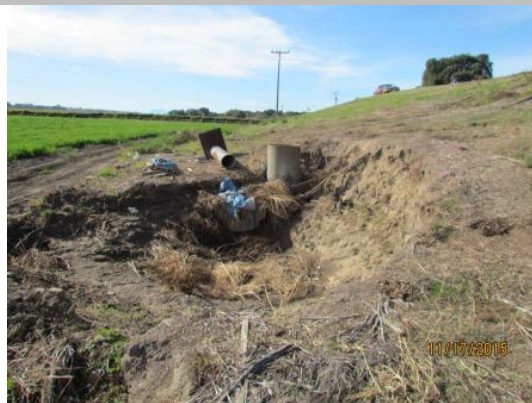
View of the ditch on the landside toe of the levee during fall 2015 inspection.

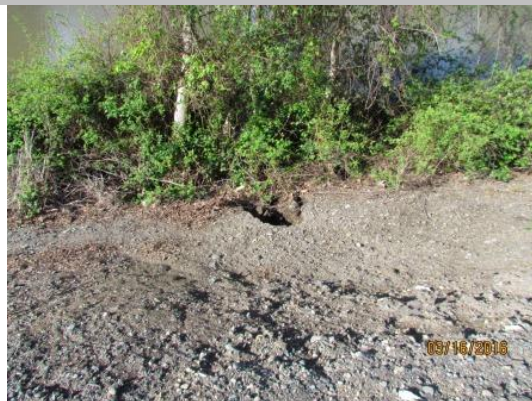
Erosion was found on the waterside toe of the levee. Spring 2016

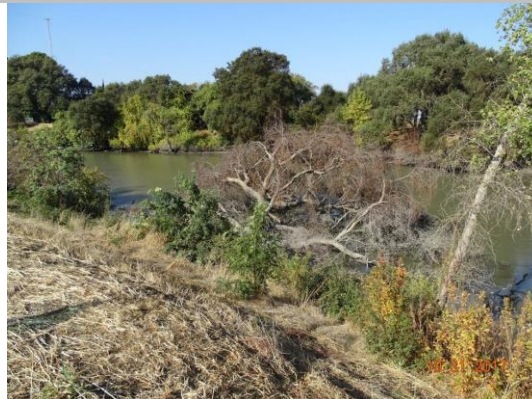
View of a fallen tree on the waterside toe of the levee. Fall 2017

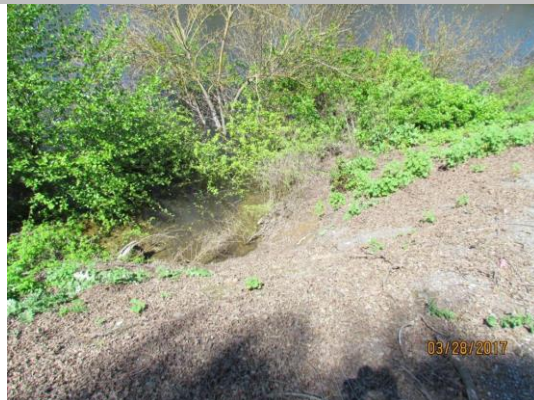
View of an erosion on the waterside toe of the levee. Spring 2017

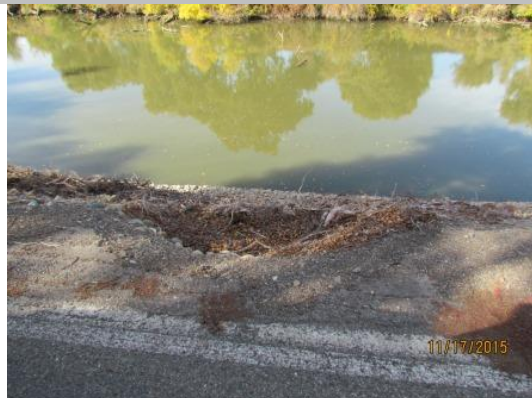
View of slope instability on the waterside shoulder of the levee during fall 2015 inspection.

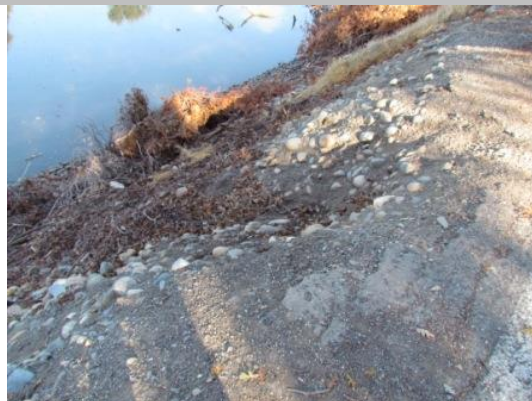
Slope instability was found on the waterside of the levee looking upstream.

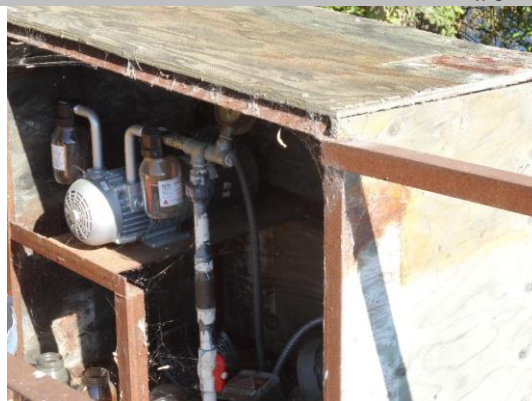
WS view: a smaller pump on steel deck. It was working during the survey.

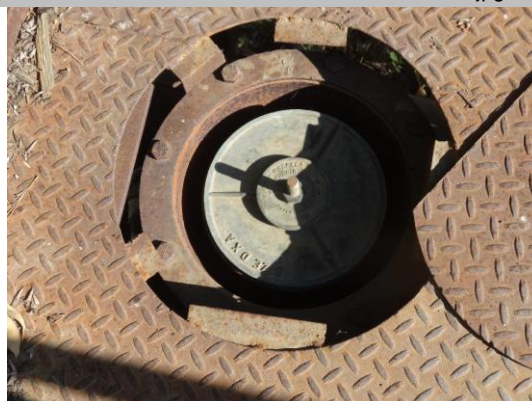
WS view: siphon breaker on pipe in steel deck on stream bank.

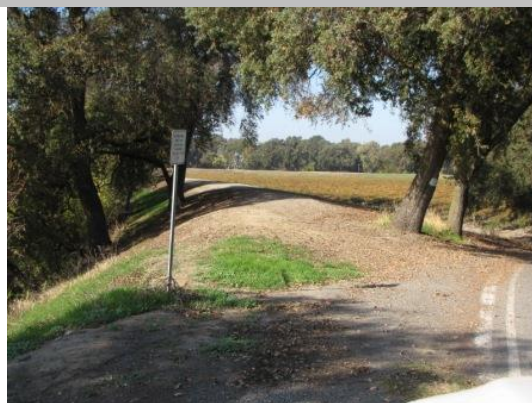
View of varying elevations in the crown of the levee at the transition from county road to access road.

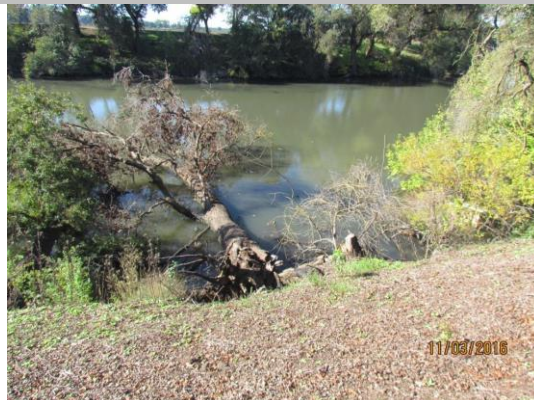
LM Start	5.15	Rating **	A/W	Issue No.	72
LM End	5.15	Issue Type +	Ma	Location *	WS
Category	Earthen Levee			GPS Latitude/Longitude	
				Start	End
Item	Encroachments			38.380940 °	38.380940 °
				-121.540384 °	-121.540384 °
DWR ID	DWR_RD0150_03_f_2016_72				
Comment Code					
TR : Tree or limb					
Inspector Comment					
Tree stump and broken tree were found on the waterside toe.

View of tree stump and broken tree on the waterside toe of the levee.  
Fall 2016

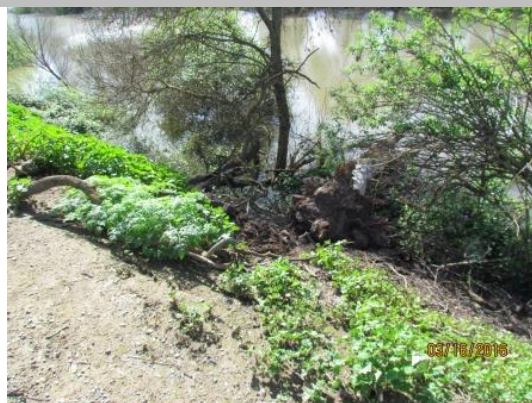
Broken tree roots and tree trunks were found on the waterside toe of the levee. Spring 2016

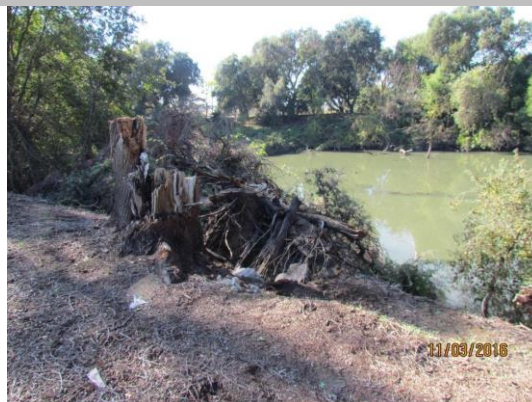
LM Start	5.49	Rating **	N	Issue No.	74
LM End	5.49	Issue Type +	Ma	Location *	WS
Category	Earthen Levee			GPS Latitude/Longitude	
				Start	End
Item	Trim / Thin Trees			38.383051 °	38.383051 °
				-121.545735 °	-121.545735 °
DWR ID	DWR_RD0150_03_f_2016_74				
Comment Code					
T5 : Tree stumps.					
Inspector Comment					
Tree stump and broken tree on the waterside shoulder of the levee need to be removed.

View of tree trunks on the waterside shoulder of the levee. Fall 2016

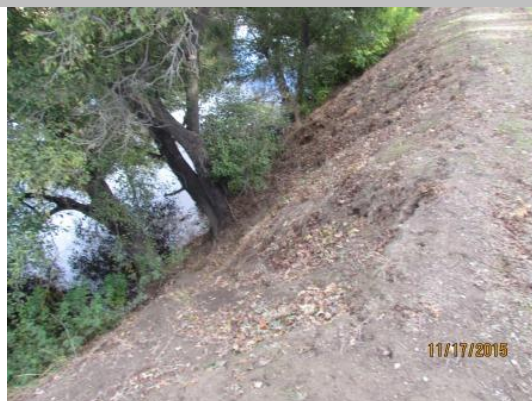
View of erosion on the waterside of the levee. Fall 2015

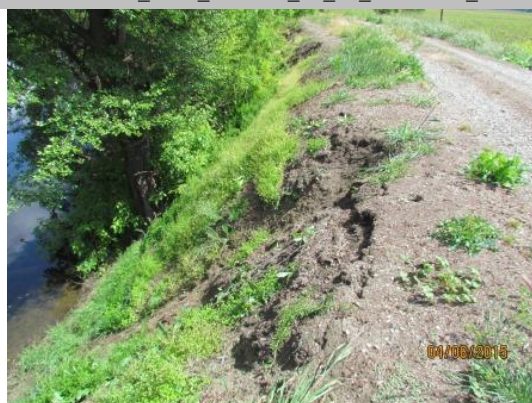
View of erosion on the waterside of the levee. Spring 2015

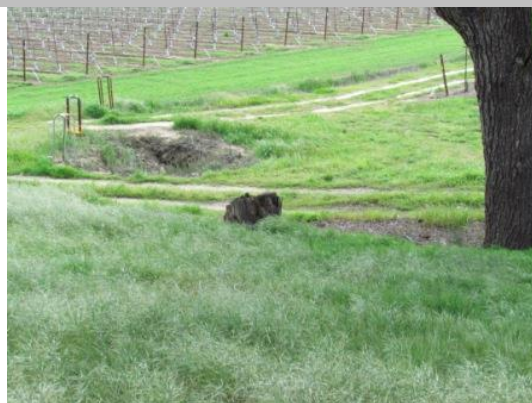
A tree stump was found on the landside of the levee looking upstream.

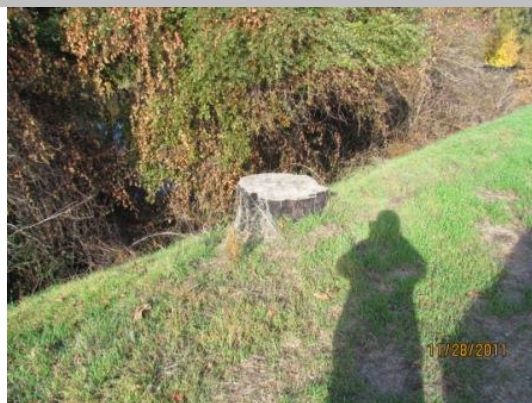
A tree stump was found on the waterside of the levee looking upstream.  
Fall 2011**\* Location**
